Critical Joints in Large Composite Primary Aircraft Structures

Volume II — Technology Demonstration Test Report

Douglas Aircraft Company
Long Beach, California 90846

Contract NAS1-16857
June 1985

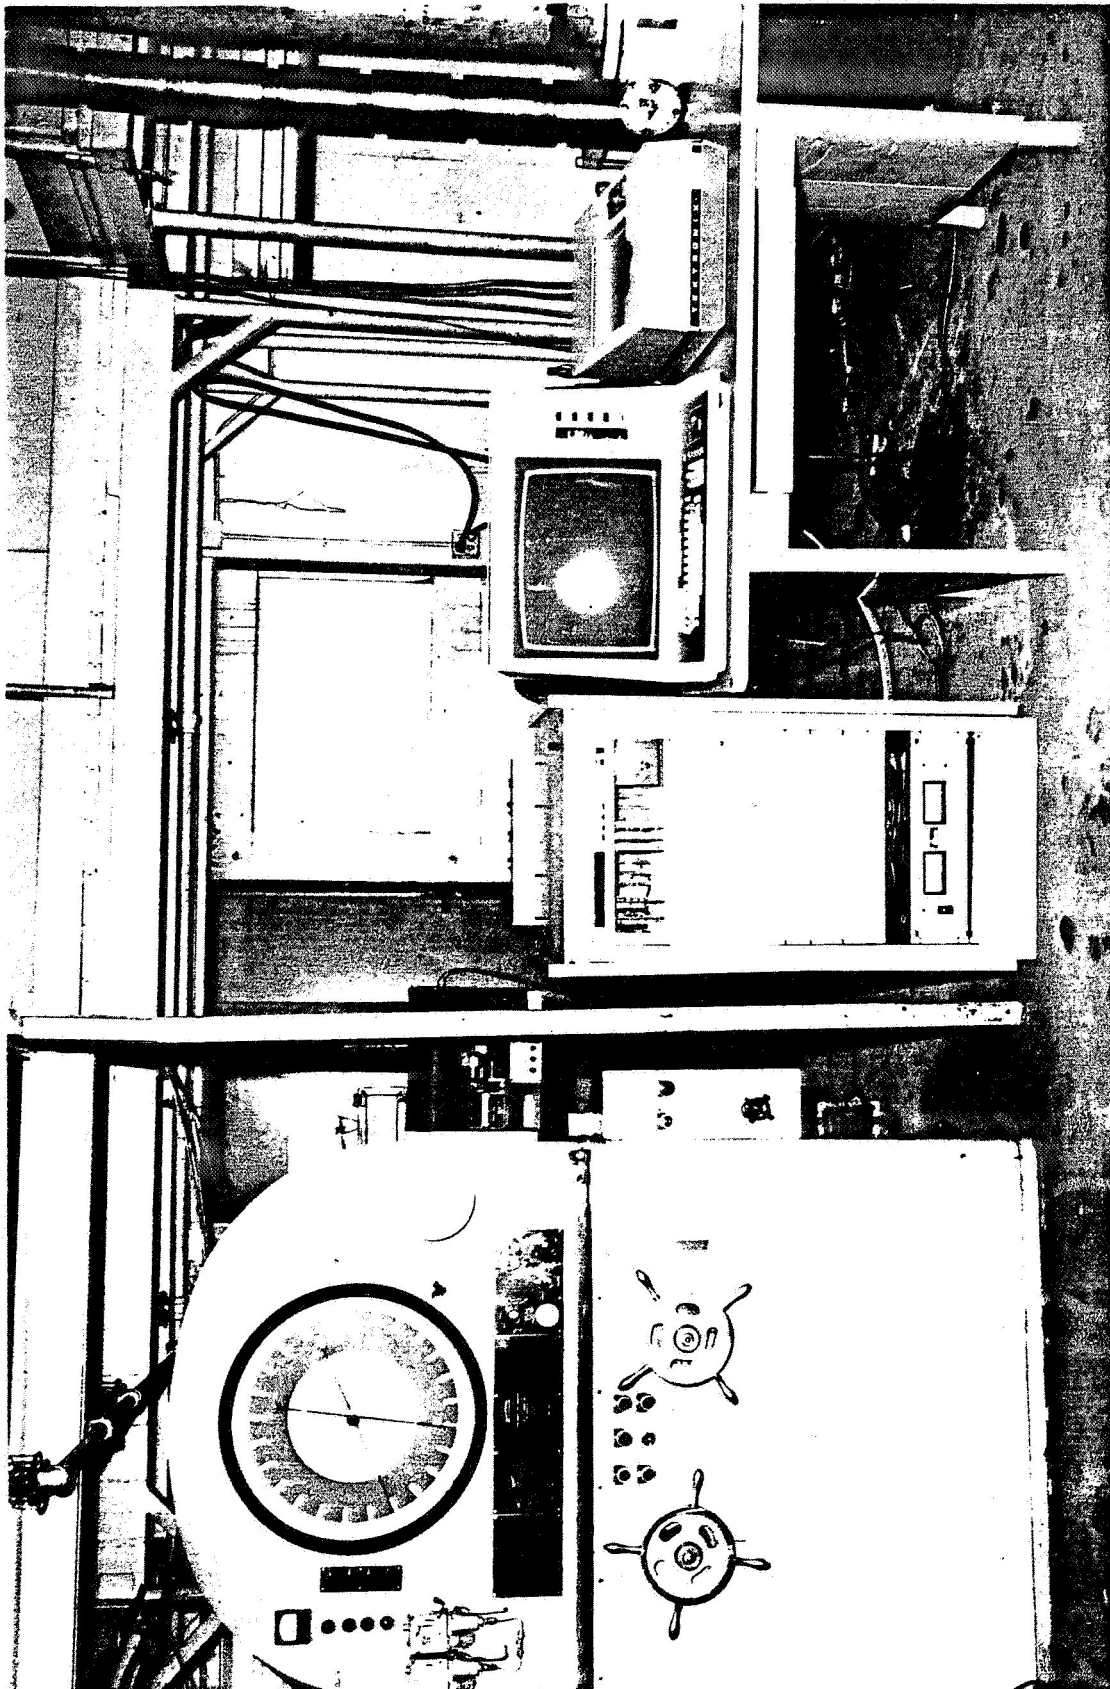
FIGURE 15 DATA ACQUISITION SYSTEM

The data acquisition system used for the test consisted of a Tektronix 4054 Graphics and Data Acquisition System, capable of single point or continuous read of strain gage and load cell output. The system is shown in Figure 15 along with a Tektronix printer which provided hard copies of the test data as required during the test. Also shown is the load control system for the mechanical test machine used to apply test loads.

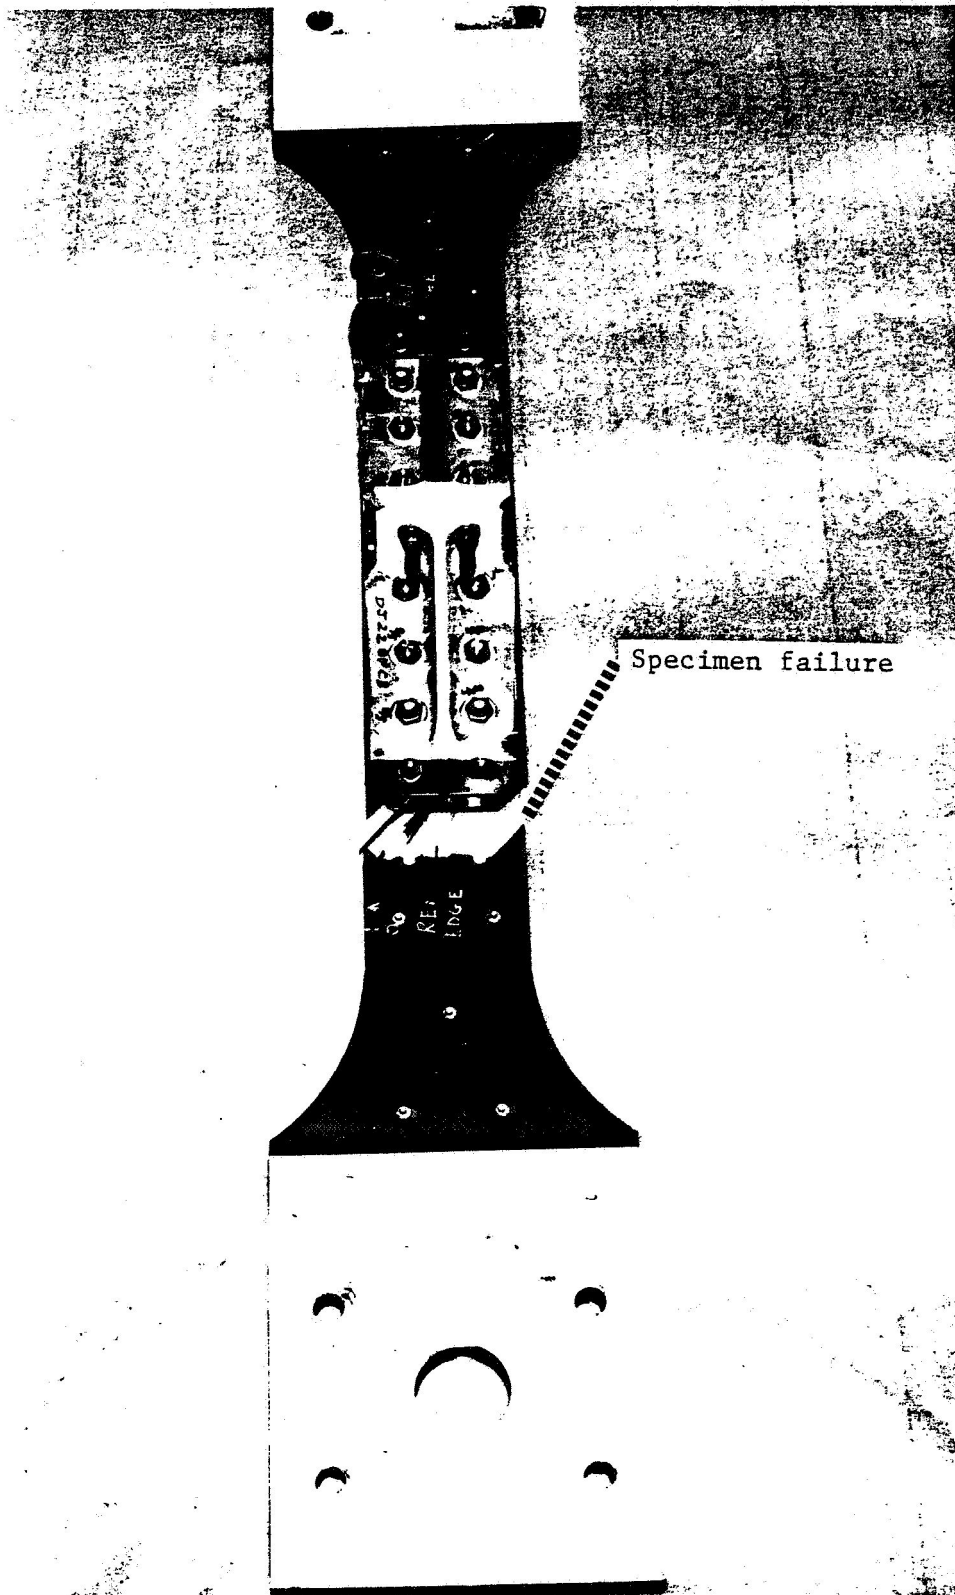
FIGURE 41 SUBCOMPONENT #1 - FAILED SPECIMEN

Subcomponent #1 was loaded in axial tension to static failure at an ultimate load of 270,000 pounds. This corresponds to an average gross-section stress and strain of about 47,500 psi and 5,100 microstrain. The failure occurred in net-section tension through the first row of fasteners entering the joint as shown in Figures 41 and 42. This was precisely the predicted failure mode, and the 270,000 pound failure load was 4% above the analytically predicted strength. The strain gage, load bolt, and load cell data gathered throughout the test are presented graphically and numerically in Appendix B. The results of a linear analysis of joint behavior have been included on each plot. As expected, very little load was passed through the aluminum fitting, which sat above one of the titanium splices through which most of the load was transferred. The onset of nonlinearity in the specimen behavior is evident from the load-strain plots at roughly the 200,000 pound load level. (No evidence of damage or nonlinear effects were observed during the visual inspection at the 160,000 pound load level.) Note that while the analysis results plotted along with test data in Appendix B were derived from a linear solution, the final joint strength prediction shown in Table II was based on the results of a nonlinear solution.

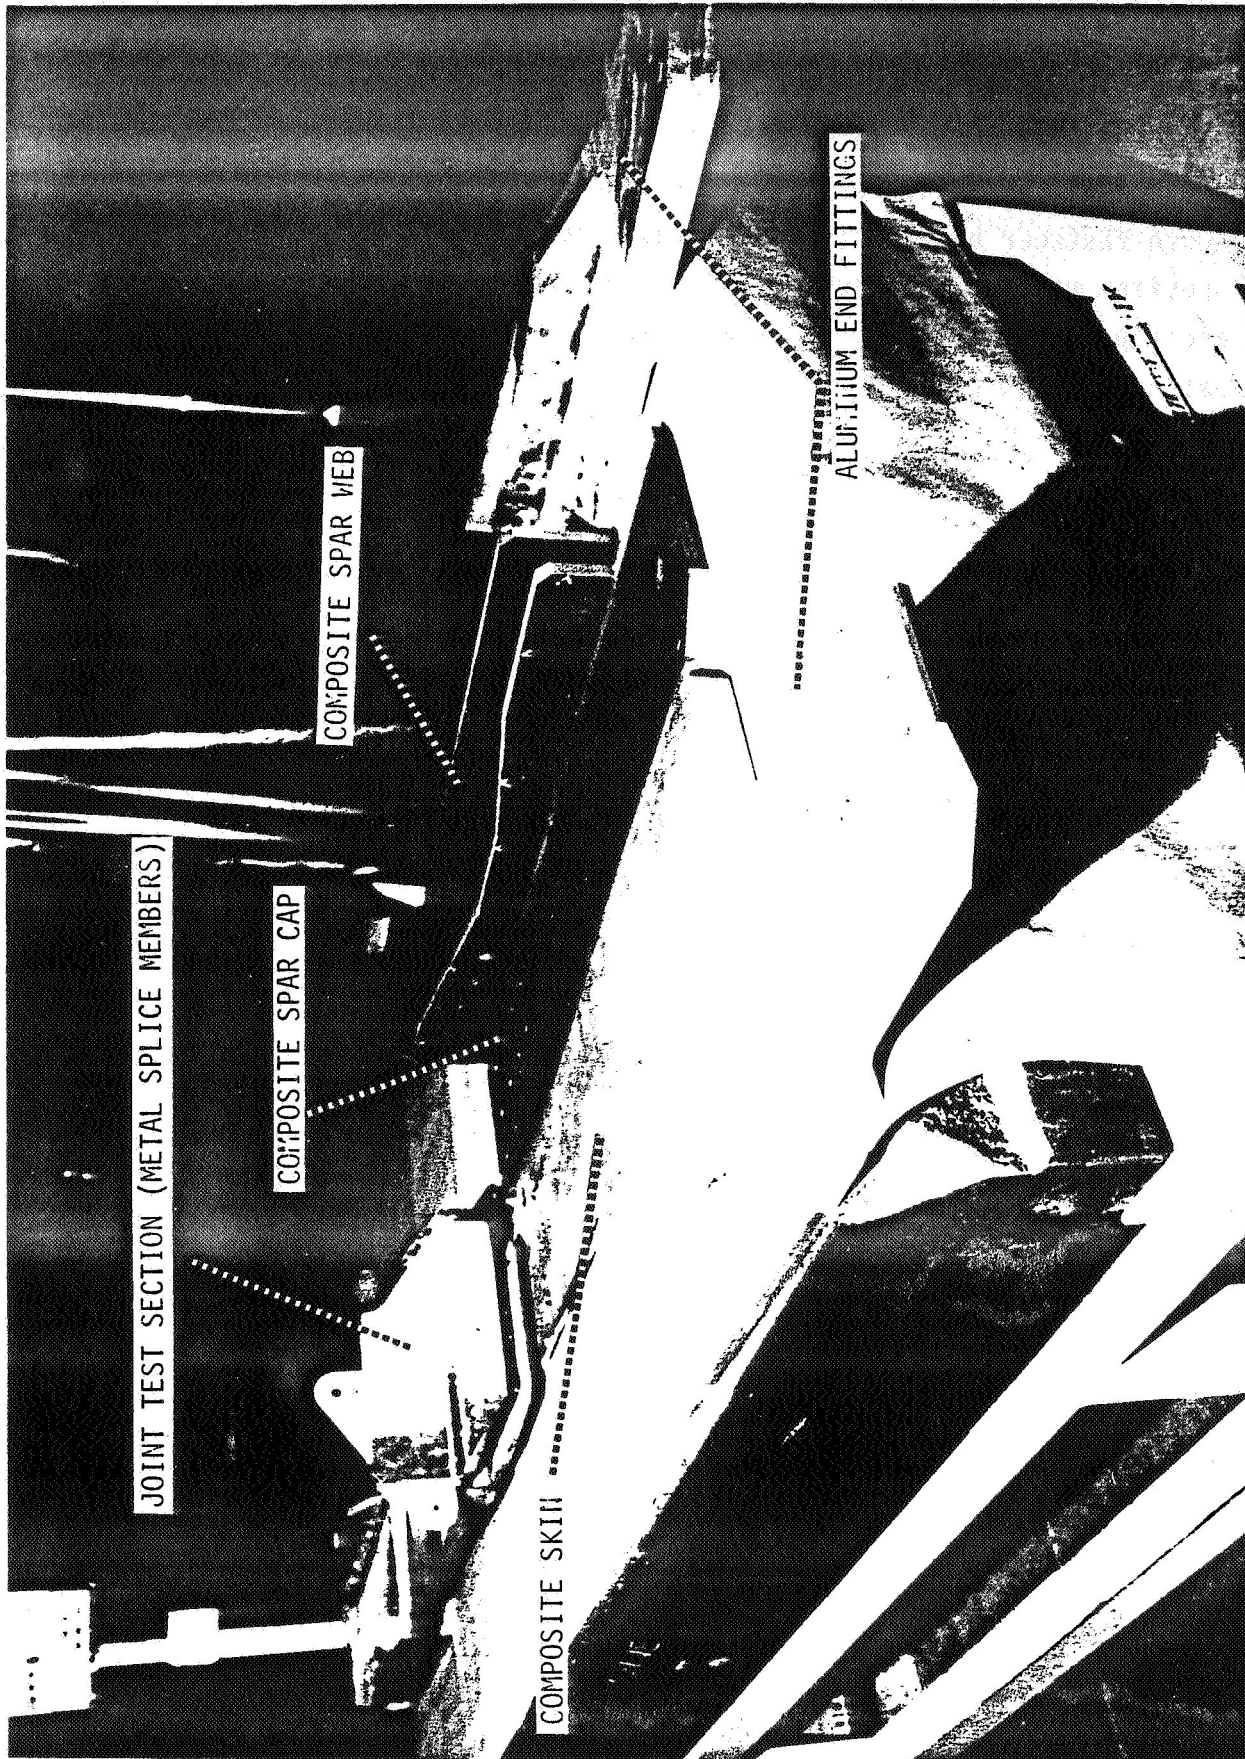
FIGURE 49 TECHNOLOGY DEMONSTRATION SPECIMEN ASSEMBLY

The specimen is shown at various stages of assembly in Figures 49 through 52. All of the composite joint members were flat plates, except for the spar cap members which were angle sections. The two spar cap members were fabricated on an aluminum male tool with the required thickness transitions machined into the tool surface. The spar cap member is shown in Figure 49 with the rest of the elements, trimmed to final dimensions with fastener holes drilled and ready for assembly. Figure 50 shows the specimen partially assembled. Titanium fasteners were used in all cases and tapered metallic surfaces were spotfaced to accommodate fastener seating. A closeup view of the bolted joint area is shown in Figure 52.

All test laminates were c-scanned prior to assembly. In all but one case, the c-scan results identified no anomalies. However, a c-scan of one of the spar cap members did show a region of questionable quality in the standing leg of the spar cap. The problem area appeared in the 0.50-inch thick section prior to the thickness buildup into the end fitting. Since the test was to be conducted under static tension loads only (no fatigue or load reversal), the decision was made to accept the part and complete the assembly. Field fasteners were added to the specimen prior to testing, representing the typical out-board attachments between the skin, spar, and web elements. Standard bolt torque values were used in all cases.

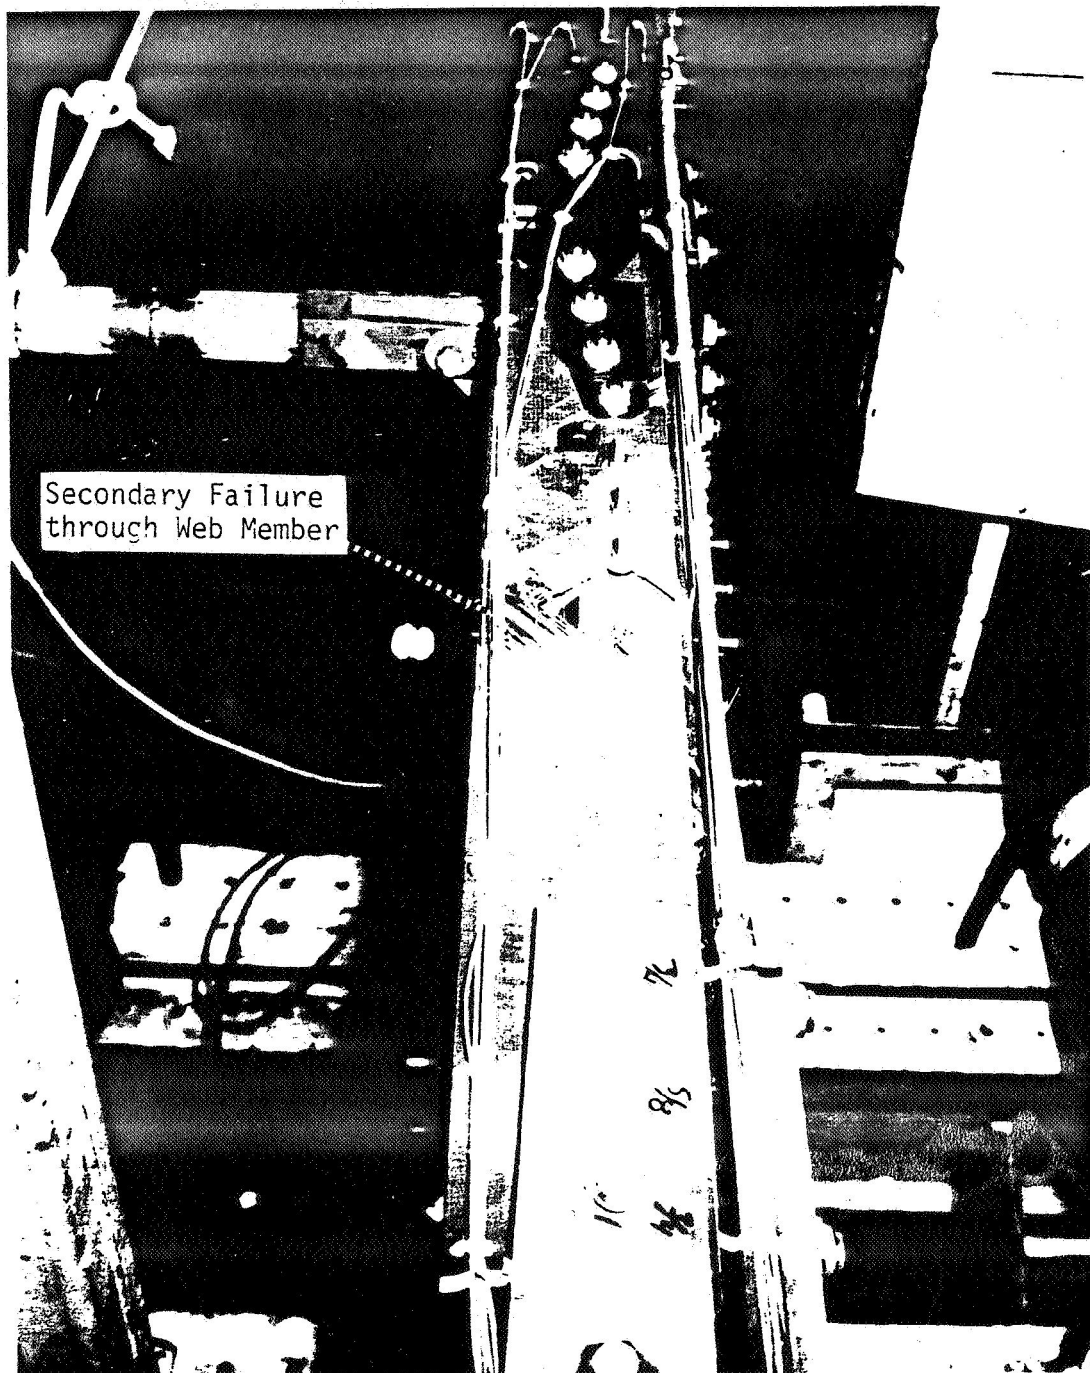
FIGURE 65 TECHNOLOGY DEMONSTRATION TEST #1 - END FITTING FAILURE

Failure of the specimen occurred at an applied tension load of 488,000 pounds, roughly 92 percent of the predicted test section strength (based on equal load sharing between skin and cap members). However, the failure was located in the end fitting area, away from the joint test section, as shown in Figures 64 and 65. A closeup view of the failure shown in Figure 66 shows that the spar cap member was actually delaminated starting at buildup in thickness on the inner surface of the cap to the first row of fasteners in the end fitting, where a net-section failure occurred in the reduced thickness of the spar cap member. The skin and web members failed through the first row of field fasteners. Although it is not possible to verify the actual cause of failure, it appears that the failure was in fact, initiated by the delamination of the spar cap member. (It was this laminate, as previously discussed, which showed questionable c-scan results in the vicinity of the delamination.) It appears that once this delamination extended to the first row of fasteners in the end fitting,

the effective thickness at the net-section was reduced by one-third to the 0.50 inch thickness of the basic cap section. A net-section tension failure then occurred in the cap member. This was followed by the net-tension failure in the skin and web members at the first row of field fasteners. This failure sequence seems logical, since after failure of the spar cap member, all of the applied loads would have to be carried by the skin and web members. The first row of field fasteners thus became the first row of bolts through which load was being transferred (back into the spar), forcing the final net-tension failure to occur. A graphic representation of the failure is shown in Figure 67 .

The technology demonstration test article was fully disassembled and visually inspected. The appearance of the broken joint members substantiated the initial observations and conclusions regarding the cause and mode of failure. C-scan results of the unfailed portions of the joint show that irreversible damage had occurred in the critical joint locations. This indicates that the specimen was close to failing in the test section when the premature end fitting failure took place. The c-scan results in Figure 68 correspond well with the results of c-scans performed on the unfailed side of several Phase I subcomponent joints, which had essentially reached their ultimate load capacity, but had failed in the opposite (mirror image) side of the specimen (Reference 1).

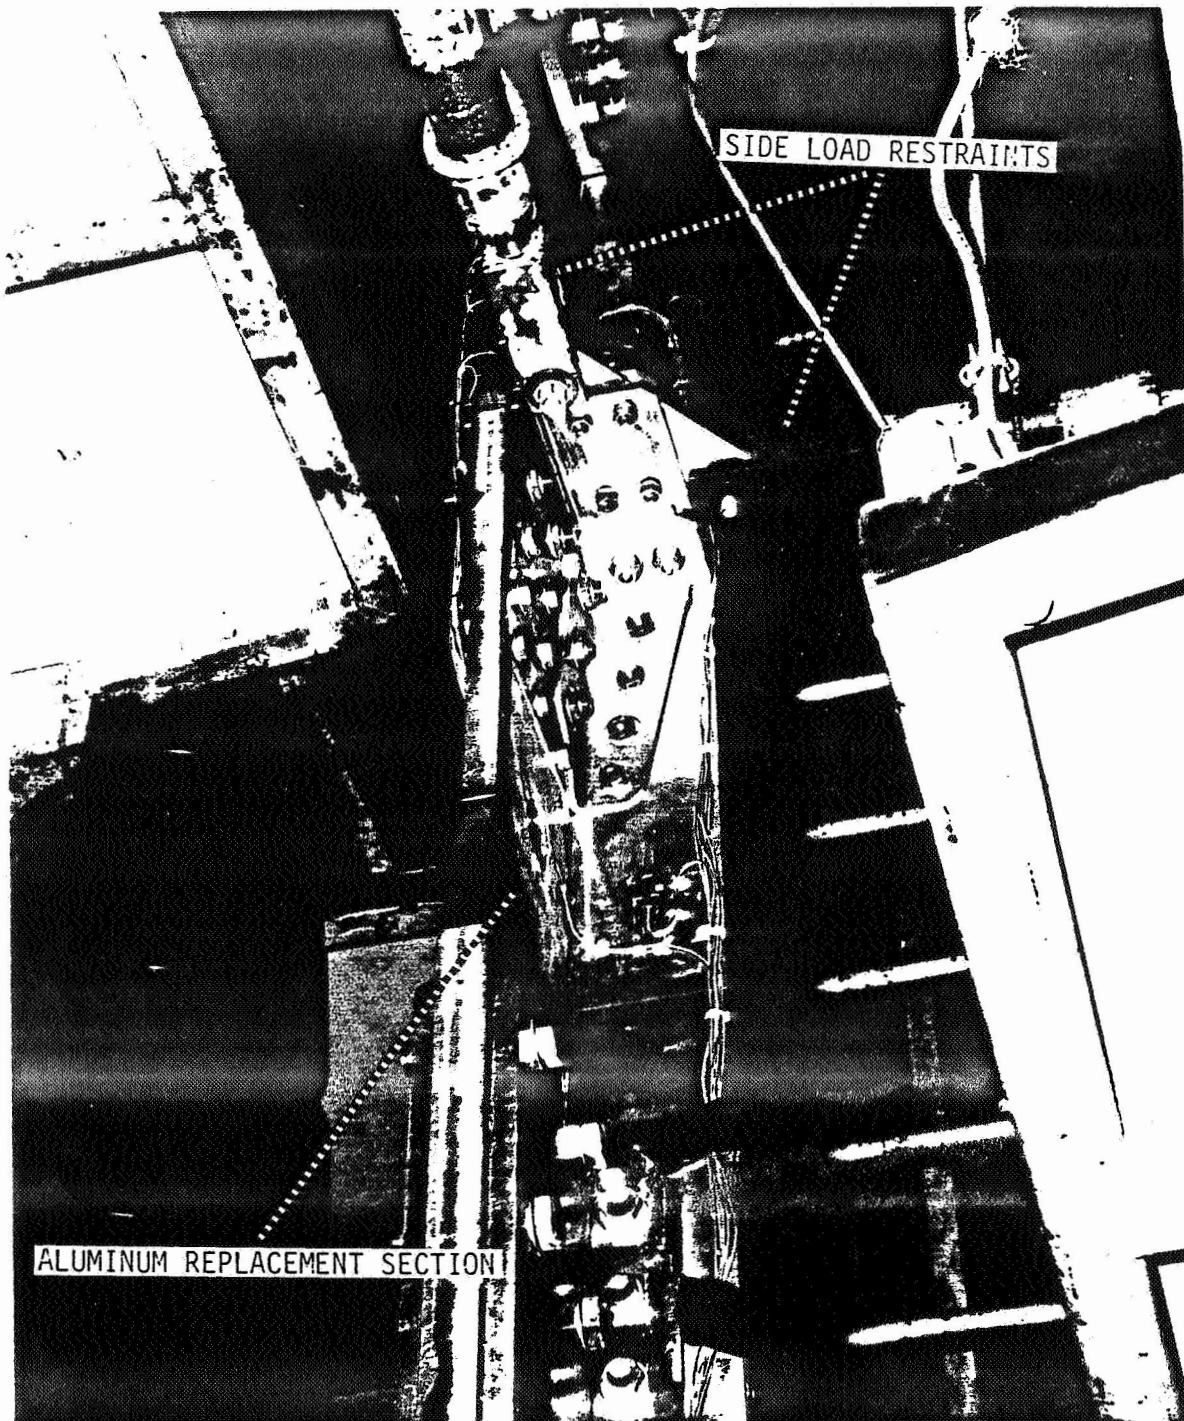
FIGURE 69 JOINT RE-TEST WITH ALUMINUM REPLACEMENT PART

After visual inspections and NDI of the unfailed parts were completed, the specimen was re-assembled from one end fitting to the joint centerline. Two aluminum plates were designed and fabricated to replace the three composite joint members from the failed side of the specimen. One aluminum plate replaced the wing skin and spar cap members, while the other replaced the upper leg of the spar cap angle section and the attached web member. The aluminum parts were machined to the exact thicknesses of the original composite parts, both in the joint test section and end fitting areas. This facilitated the specimen re-assembly by ensuring proper fit and alignment between members. The re-assembly was completed with no shimming required.

The aluminum plates were made of 7075-T6 material. Since the Young's modulus value for this alloy is within about 10% of the value for composite laminates used in the specimen, it was determined that the resulting stiffness imbalance would be minimal and have virtually no effect on the joint load distributions. The 7075-T6 material was of sufficient ultimate tension strength to ensure that the failure would occur in the composite joint members. The specimen is shown with a view of the aluminum replacement section of the joint from several angles in Figures 69 through 71 . The overall test setup is shown in Figure 72 .

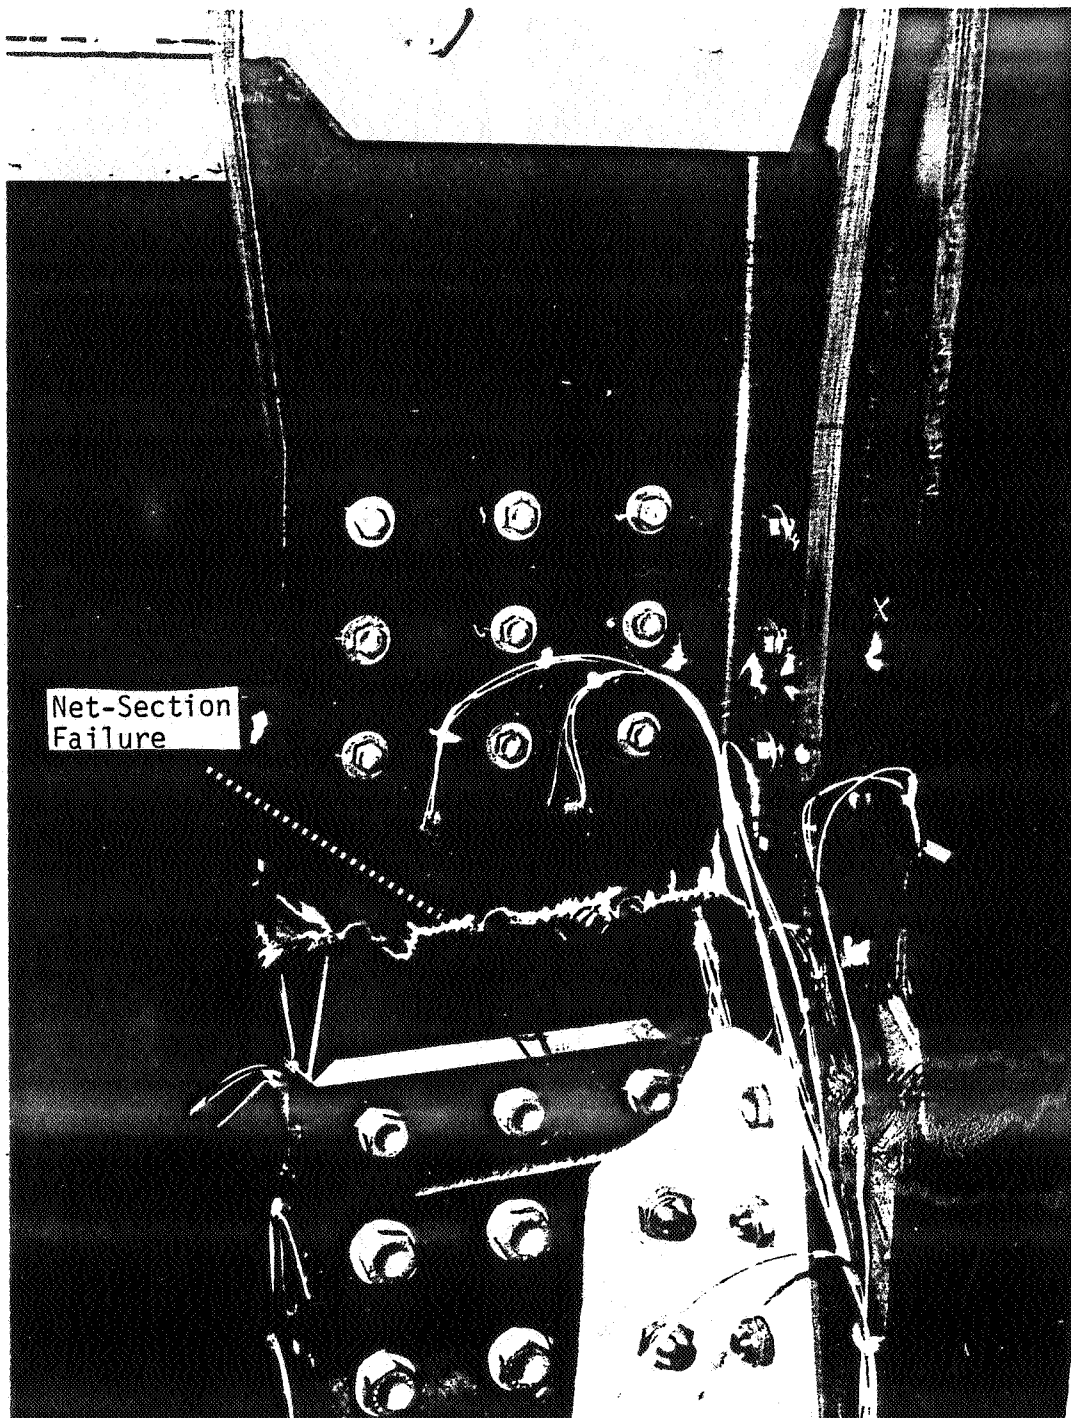
FIGURE 75 TECHNOLOGY DEMONSTRATION - TEST SECTION FAILURE

After reinstalling the specimen in the test fixture, the second static test was conducted with excellent results. The specimen failed at an applied load of 484,420 pounds with both the failure load and location showing good correlation with analytical predictions. The failure load of 484,420 pounds corresponds to a far-field stress level of around 46,500 psi. The maximum strain in the composite laminates at failure was slightly above 5000 microstrain, which occurred in the spar cap member. The failure was a net-section tension failure through the first (outermost) row of fasteners in the joint test section as shown in Figure 75. The wing skin, spar cap, and spar web members all failed through this location. Figures 76 through 78 show several views of the failed specimen, still in the test machine. In general, the failure was a very clean break, particularly through the skin and cap members where there was very little evidence of delamination.

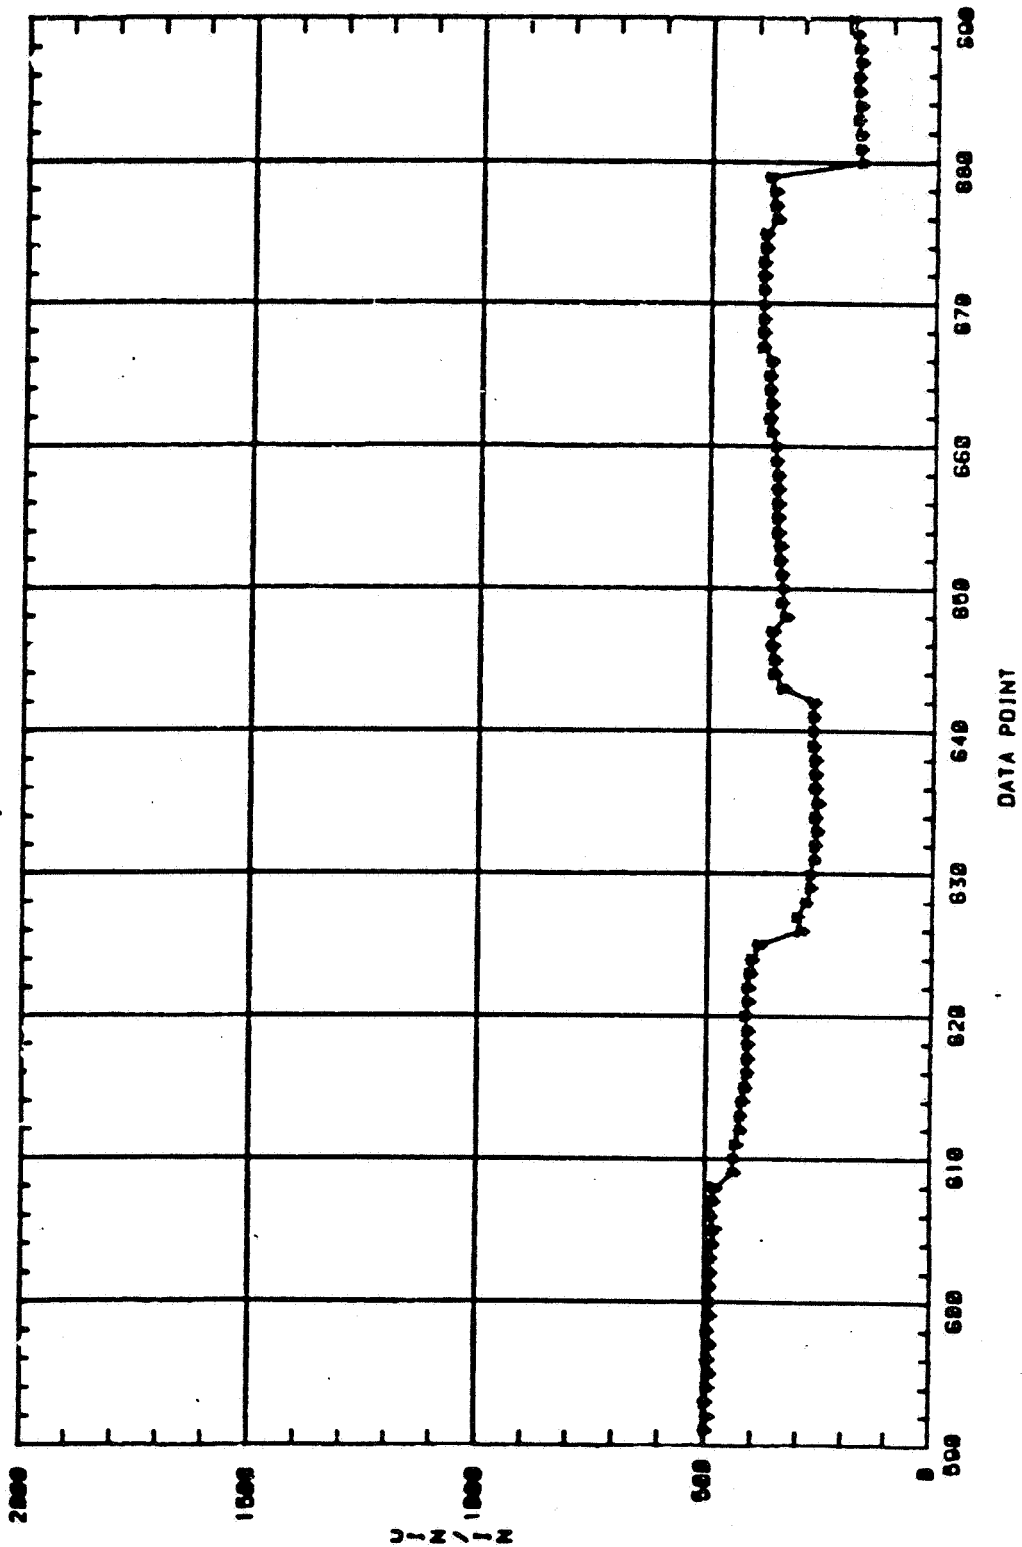
CRITICAL JOINT TEST (BLOC 3)
STRESS SURVEY & LOAD TO FAILURE
DATE: 26 JUN 84
SG12 vs DATA POINT NUMBER

SG12 During Failure Ramp

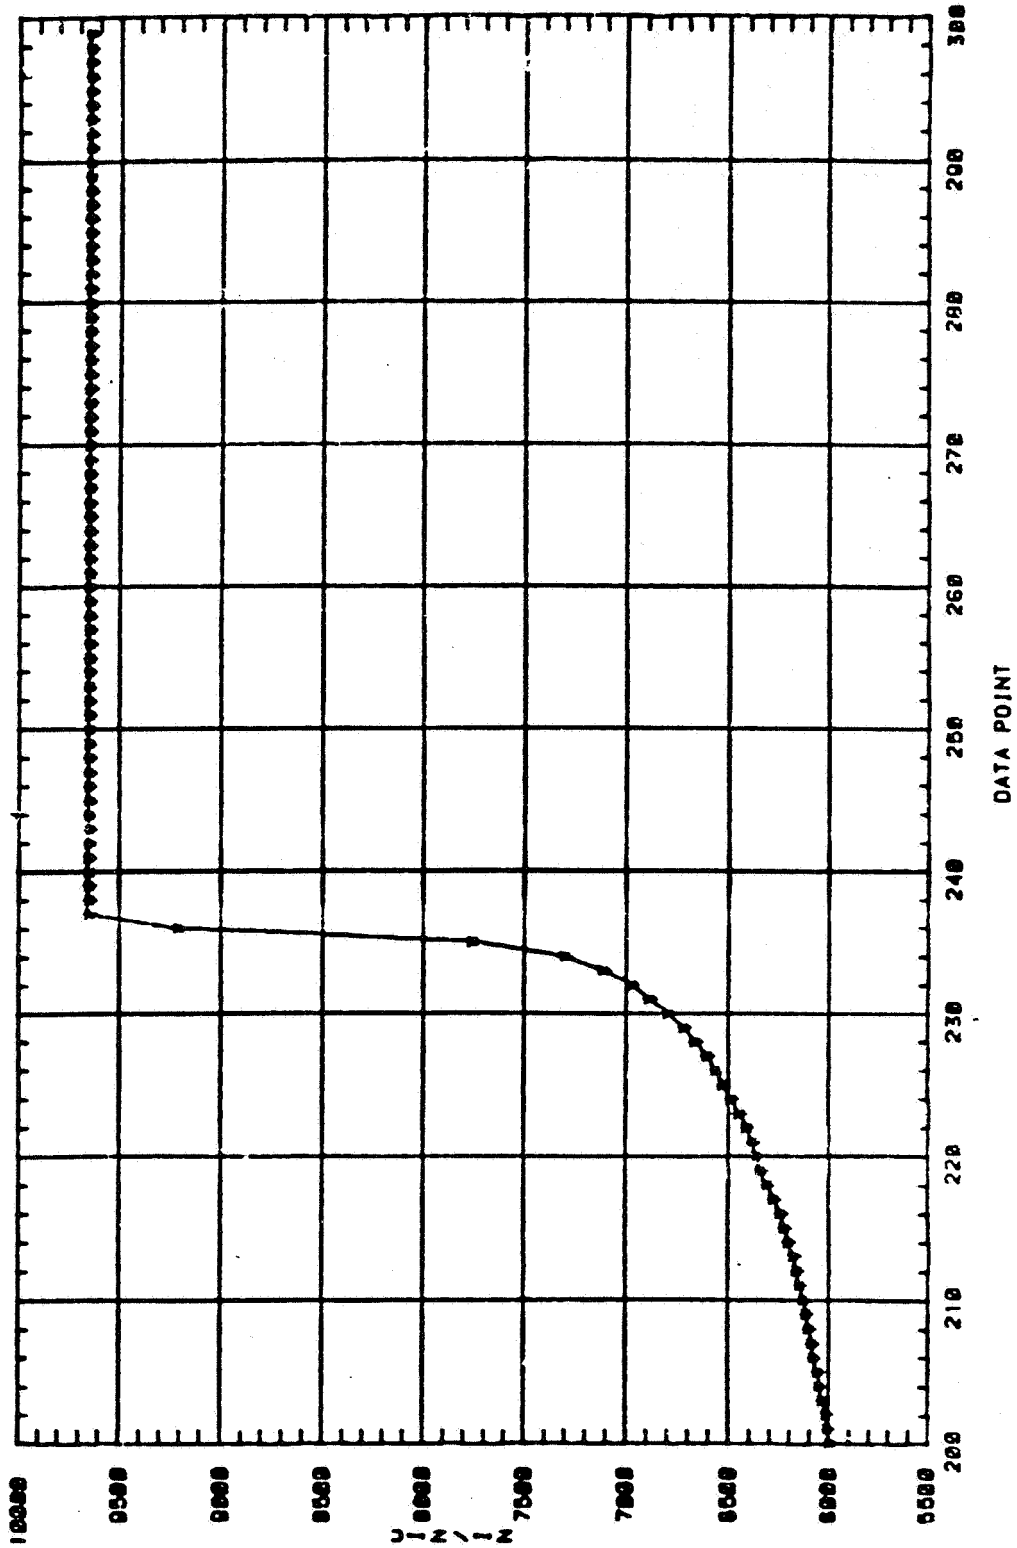
CRITICAL JOINT TEST (BLDG 3)
STRESS SURVEY & LOAD TO FAILURE

DATE: 26 JUN 84
SG13 vs DATA POINT NUMBER

Failure of SG13 During Continuous Ramp from 100,000 to 120,000 lbs.

The 9658 in/in Reading is Full Scale on the Data System
